Manhole Inspection Summary

Manhole # S31I__030MH

Insp Date: **8/11/08 2:53 PM**

Location Address: **110 s paca st**

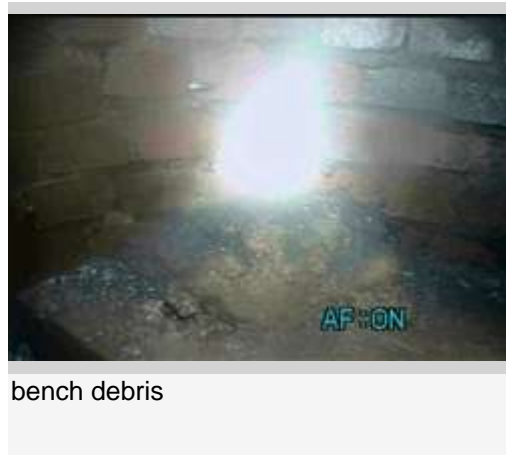
Defect 2

Condition: ☐ Sound ☐ Cracked ☐ Root Intrusion ☐ Deteriorated ☐ Leaks ☒ **Debris**

bench debris

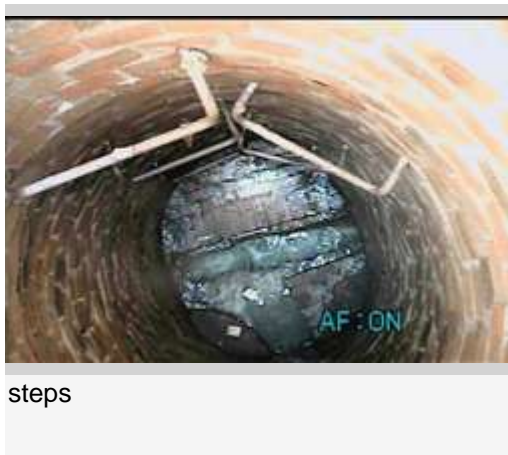
Defect 1

Count: **6** Missing: **0** ☒ **Corroded**

steps

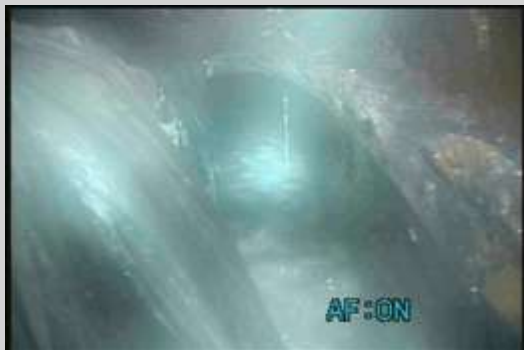
12 O'Clock Outflow

10 in. Circular Gravity Sewer
Pipe Out @ 12 O'Clock

Pipe Material: **Clay** ☐ Pipe Lined

Invert Depth: **12.00** (ft.) Flow Characteristics: **Fast**

Deposits: ☒ None ☐ Mud ☐ Sludge ☐ Debris ☐ Grease

Infiltration: **None** Pipe Seal Cond: **Unknown**

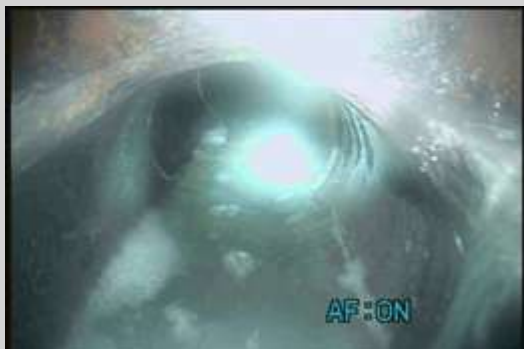
6 O'Clock Inflow

10 in. Circular Gravity Sewer
Pipe In @ 6 O'Clock

Pipe Material: **Clay** ☐ Pipe Lined

Invert Depth: **11.92** (ft.) Flow Characteristics: **Fast**

Deposits: ☒ None ☐ Mud ☐ Sludge ☐ Debris ☐ Grease

Infiltration: **None** Pipe Seal Cond: **Unknown**

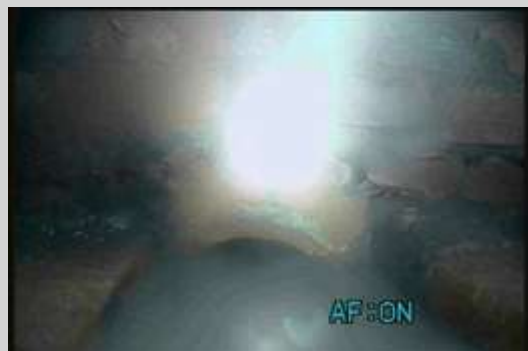
9 O'Clock Inflow

8 in. Circular Gravity Sewer

Pipe In @ 9 O'Clock

Pipe Material: **Clay** ☐ Pipe Lined

Invert Depth: **11.33** (ft.) Flow Characteristics: **Slow**

Deposits: ☒ None ☐ Mud ☐ Sludge ☐ Debris ☐ Grease

Infiltration: **None** Pipe Seal Cond: **Unknown**

Connects To: **Dead End**
